# Wood and indoor climate

# Measurements performed by Norsk Treteknisk Institutt

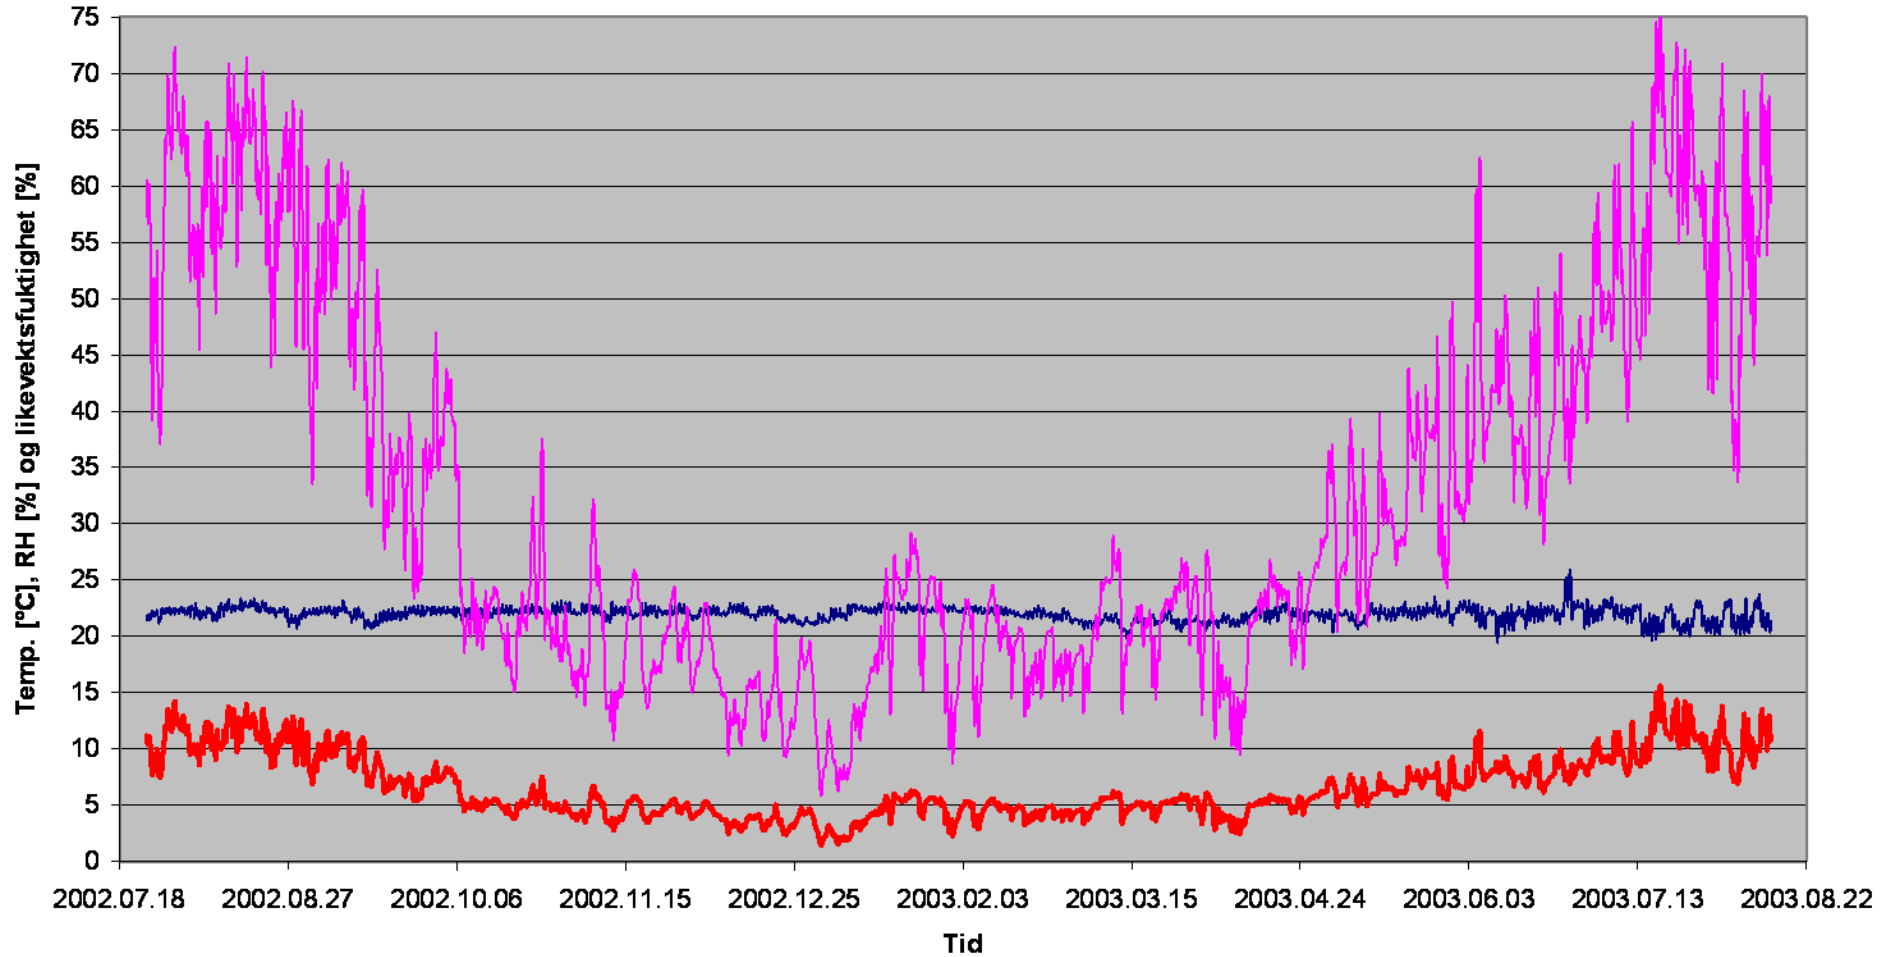
# Logged values in a large office space in Oslo - 18 July 2002 to 22 August 2003

— Temperatur — Relativ luftfuktighet — Likevektsfuktighet

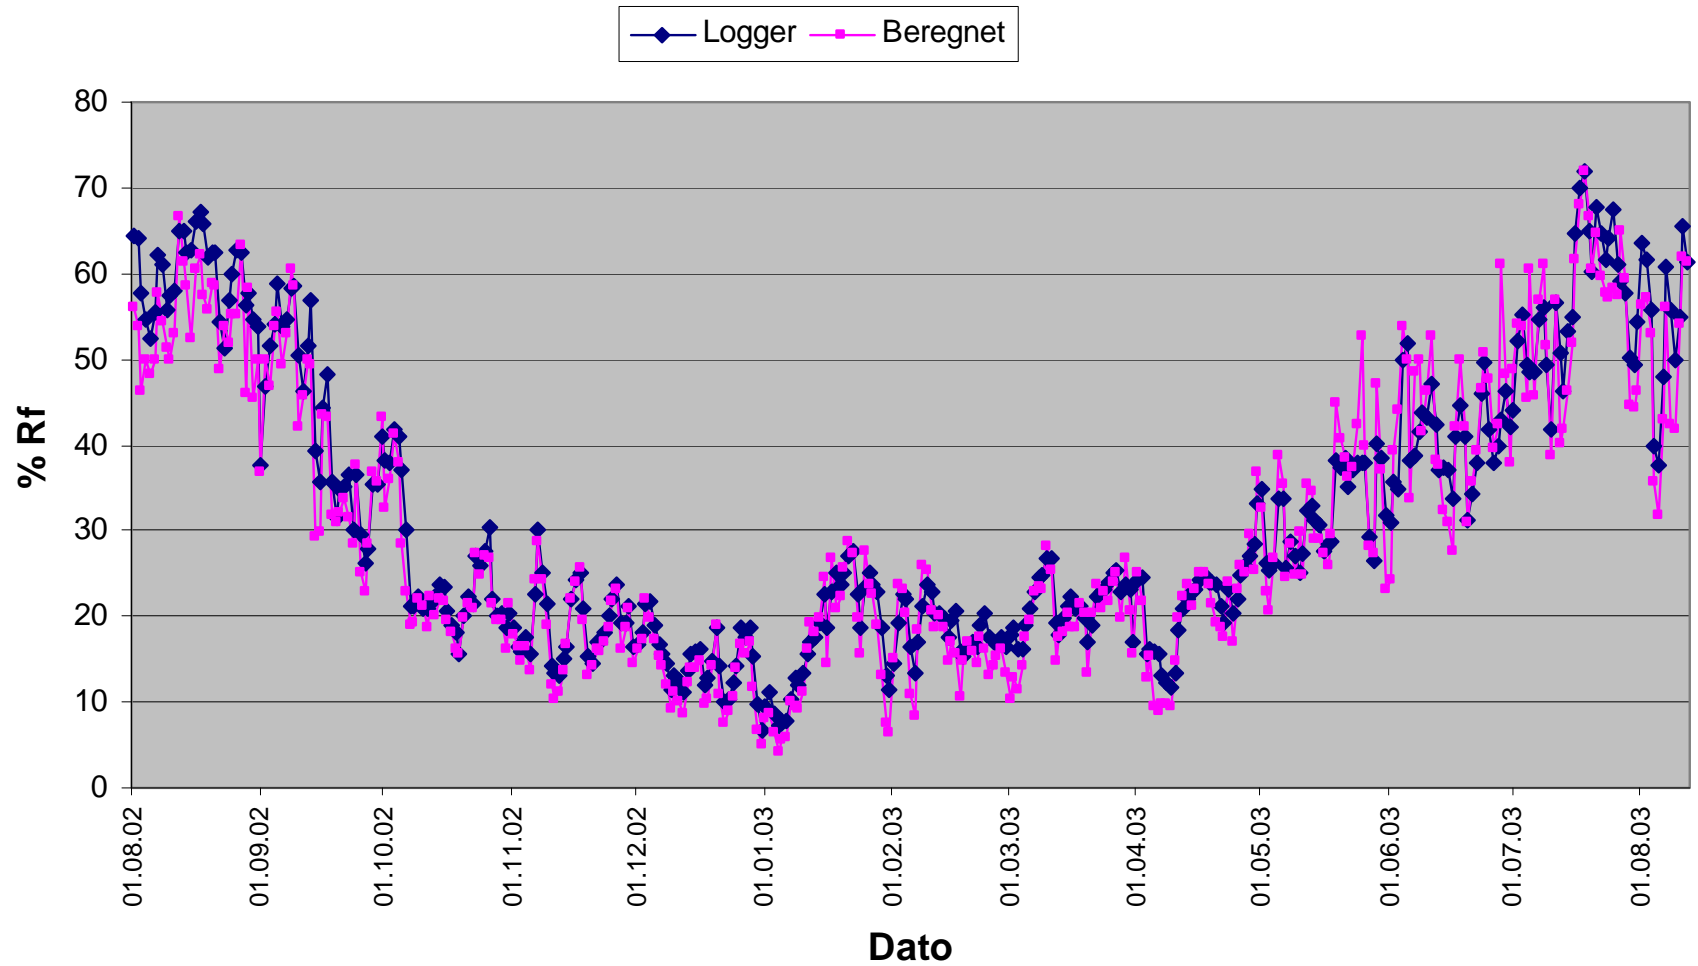
# Logged and estimated indoor climate

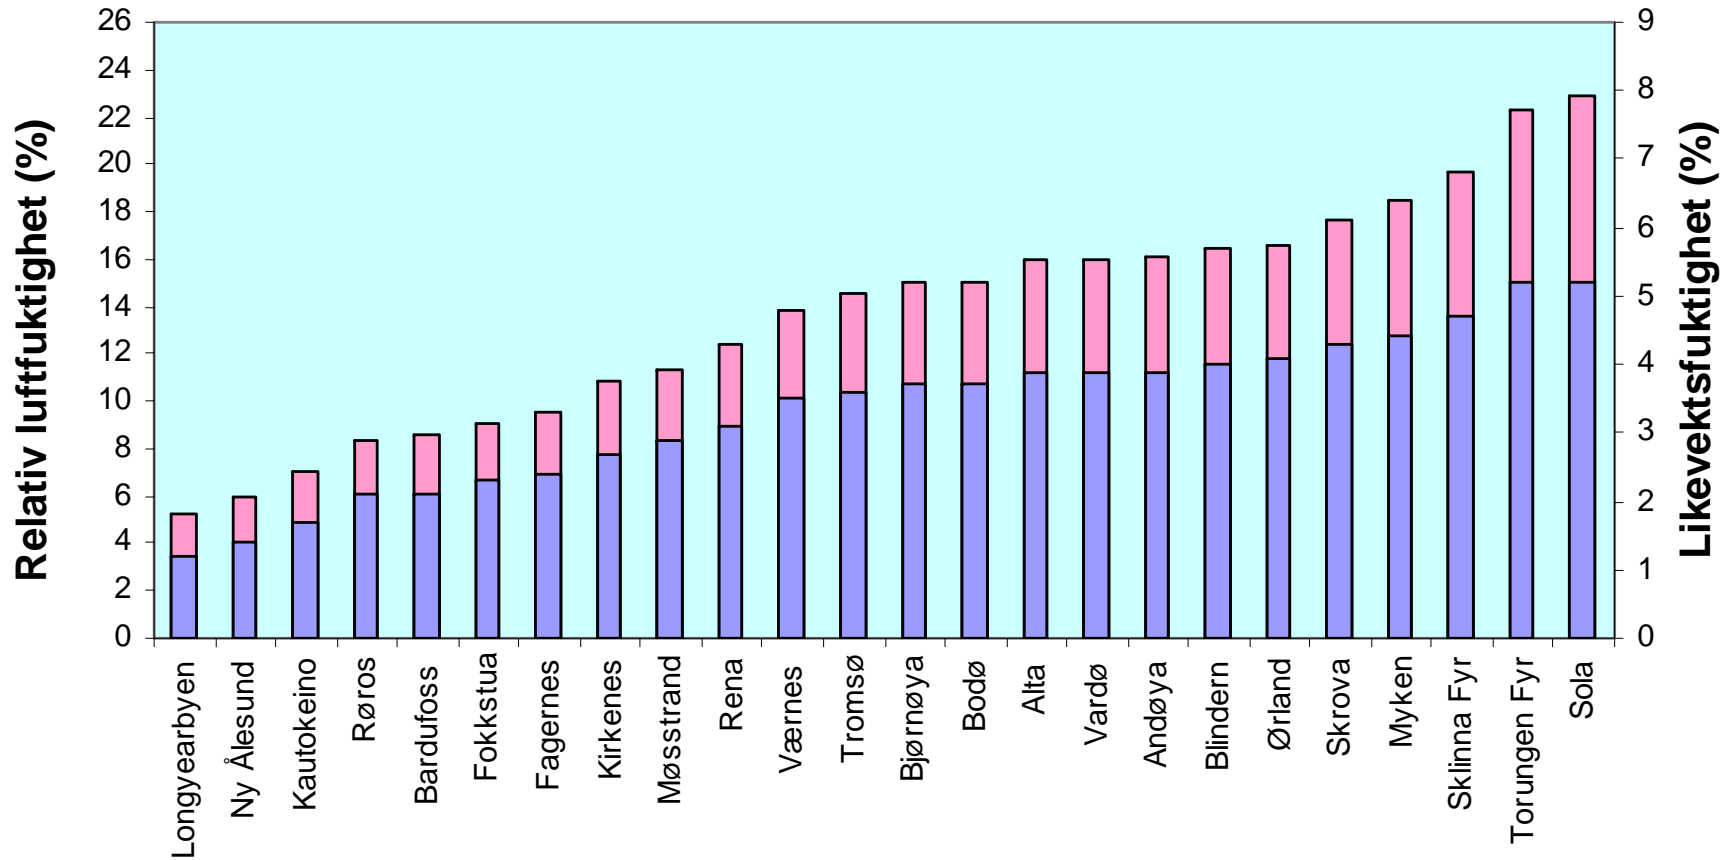
Overview for January 2004 – indoor conditions at 22 °C (monthly mean)

Relativ luftfuktighet (%) Likevektsfuktighet (%)

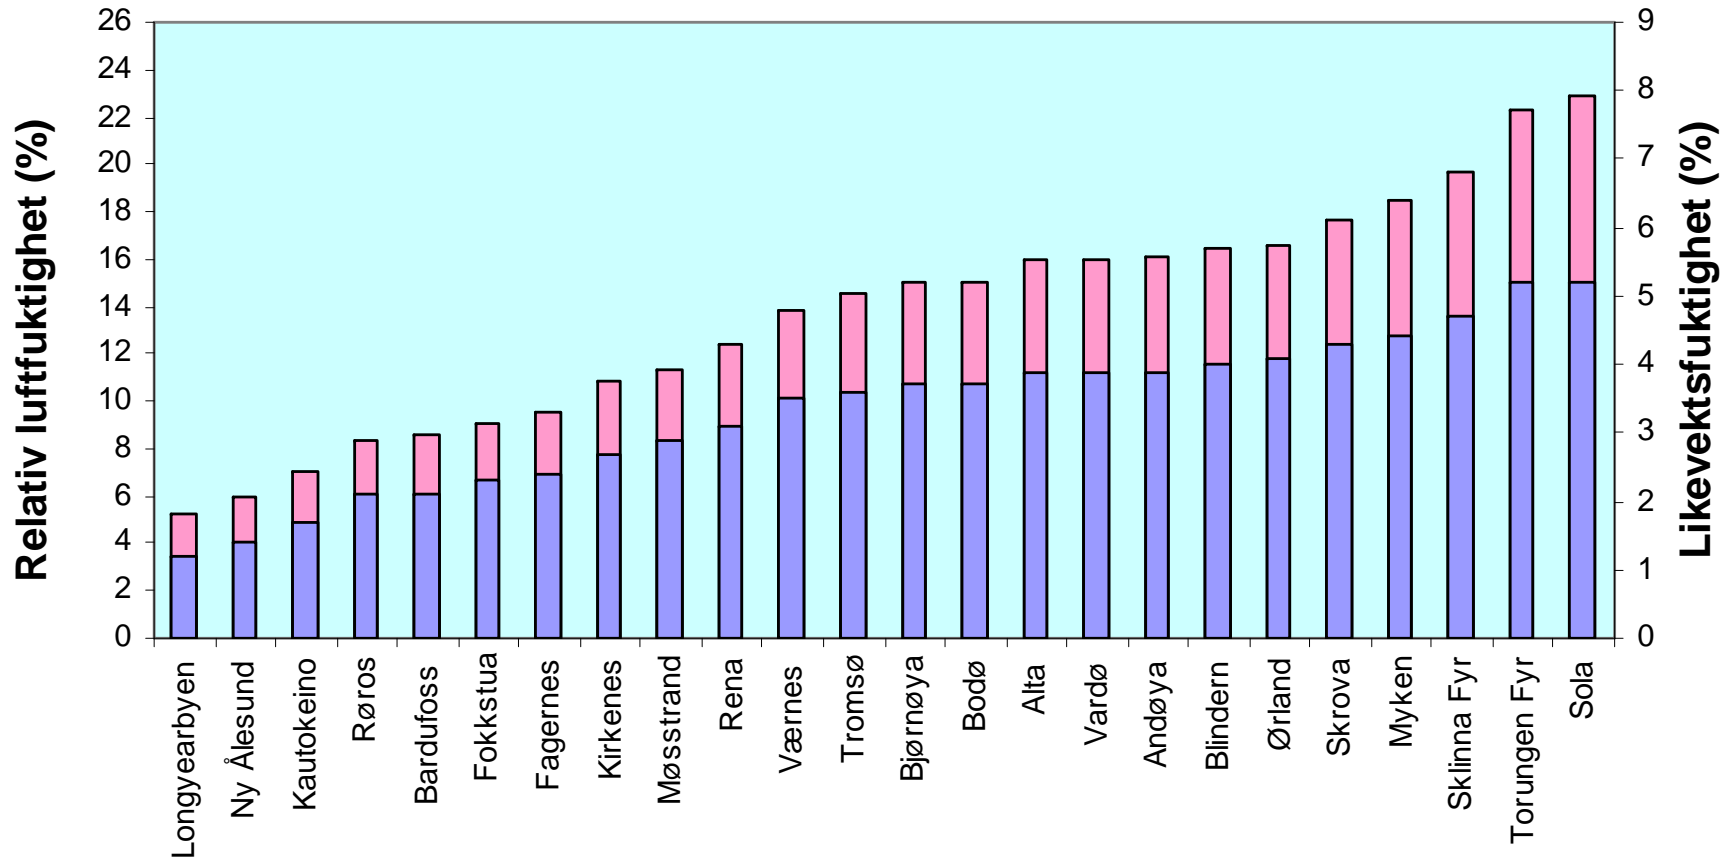
Overview for January 2004 – indoor conditions at 22 °C (monthly mean)

Relativ luftfuktighet (%) Likevektsfuktighet (%)

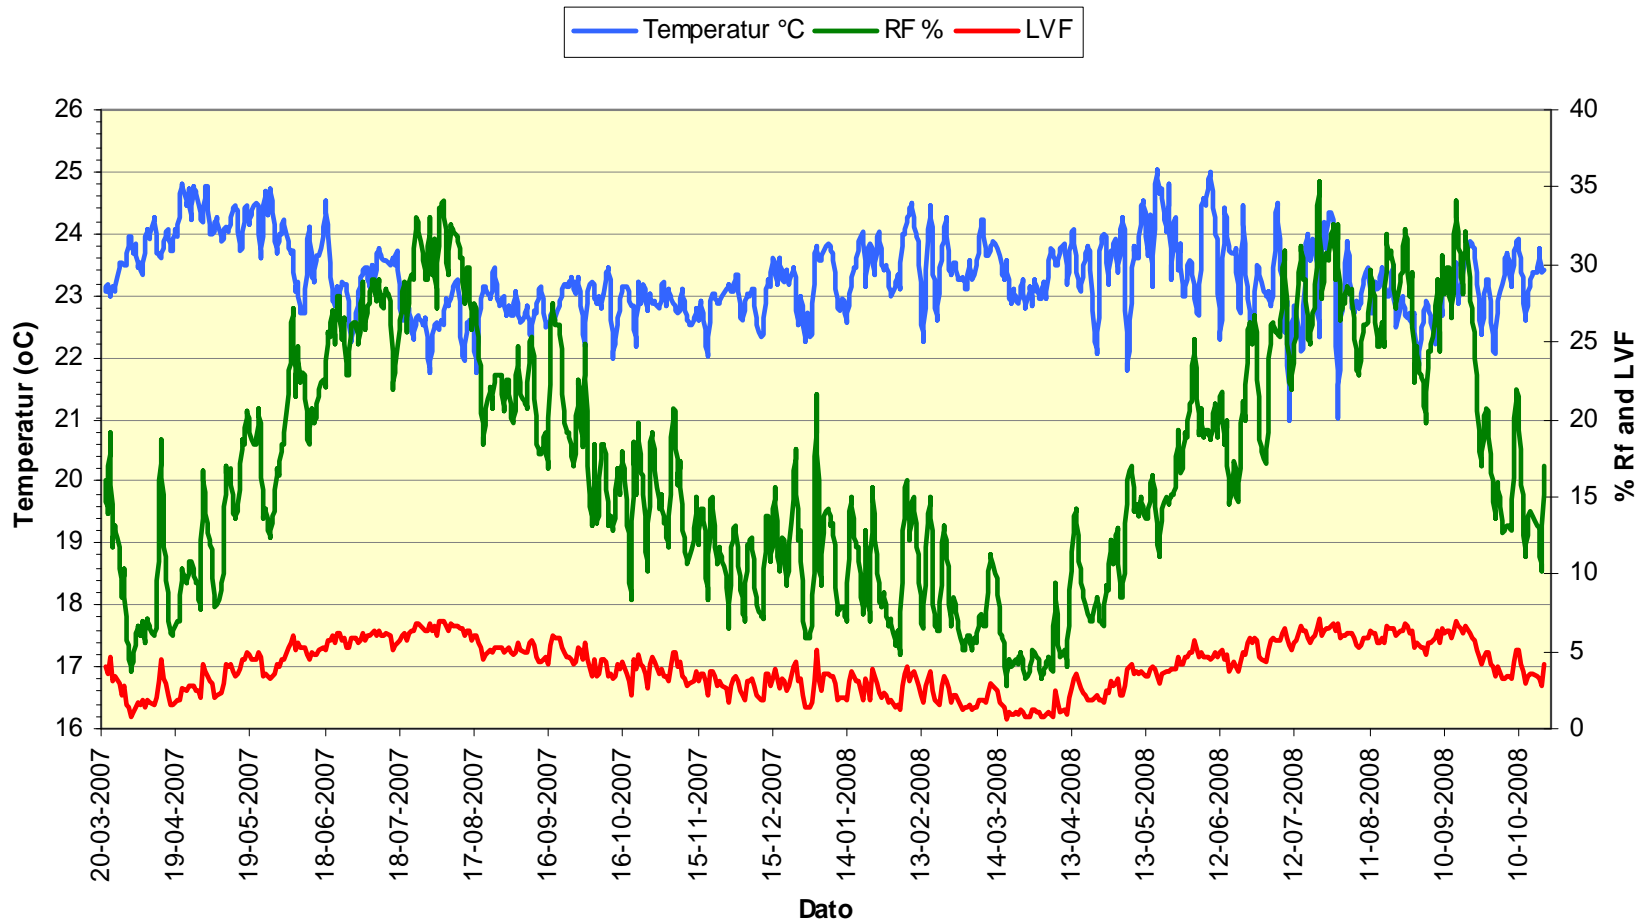
# Logged indoor climatic conditions in the university building - Longyearbyen

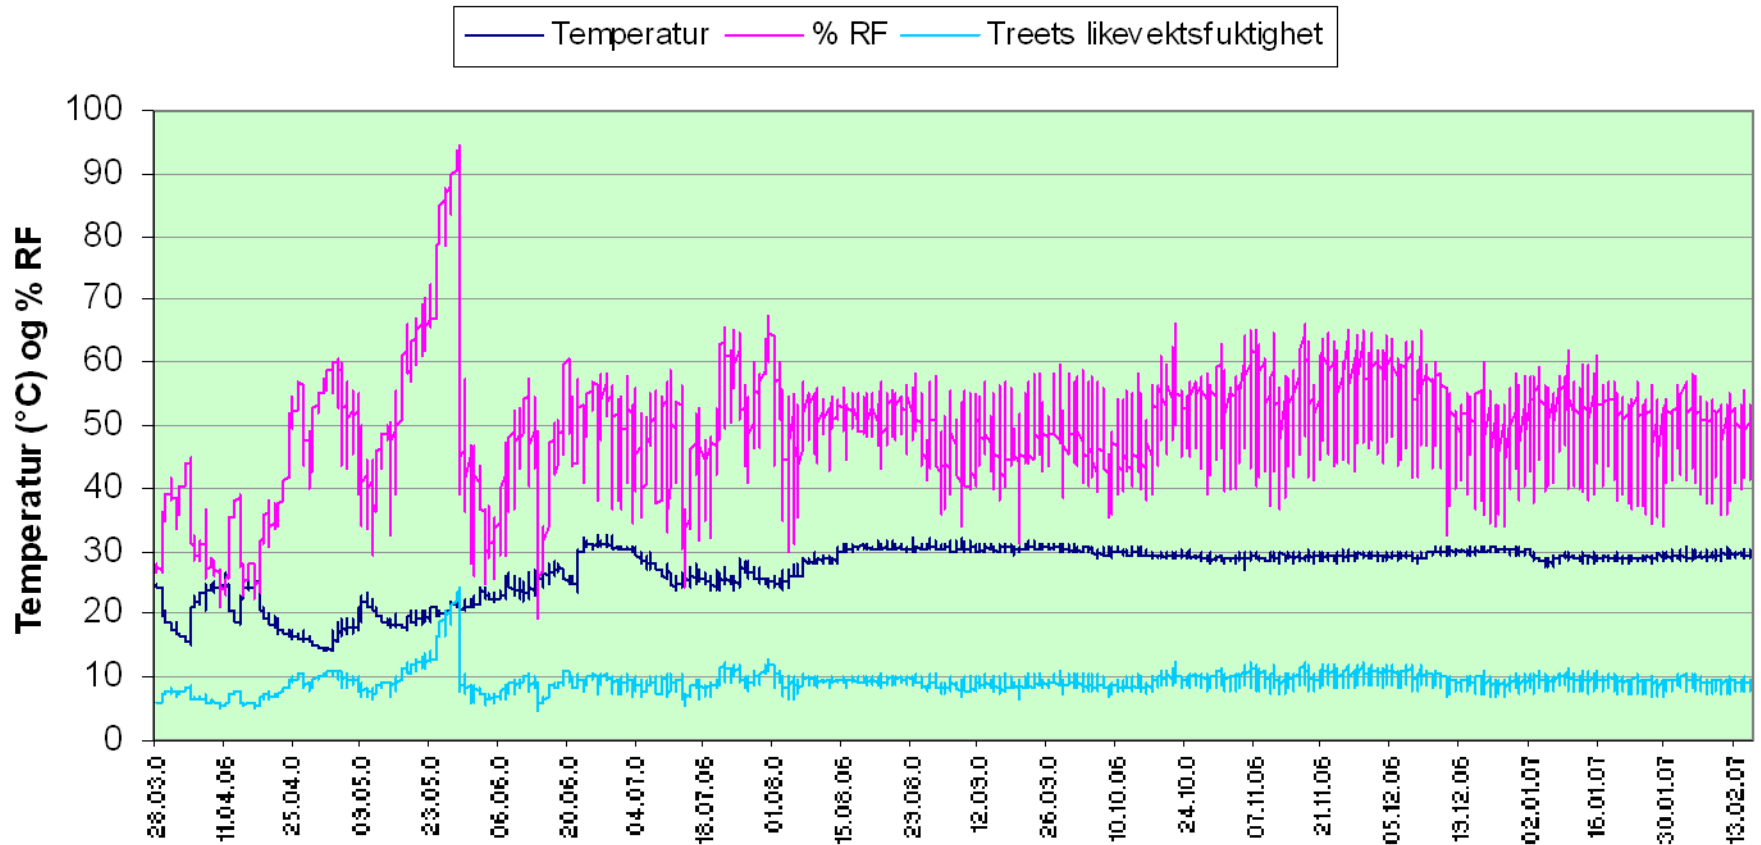
# Climate in Risenga indoor swimming pool – Asker

Logging for the period 28 March 2006 to 16 February 2007

The measurements have been done up below the ceiling near the glulam beams

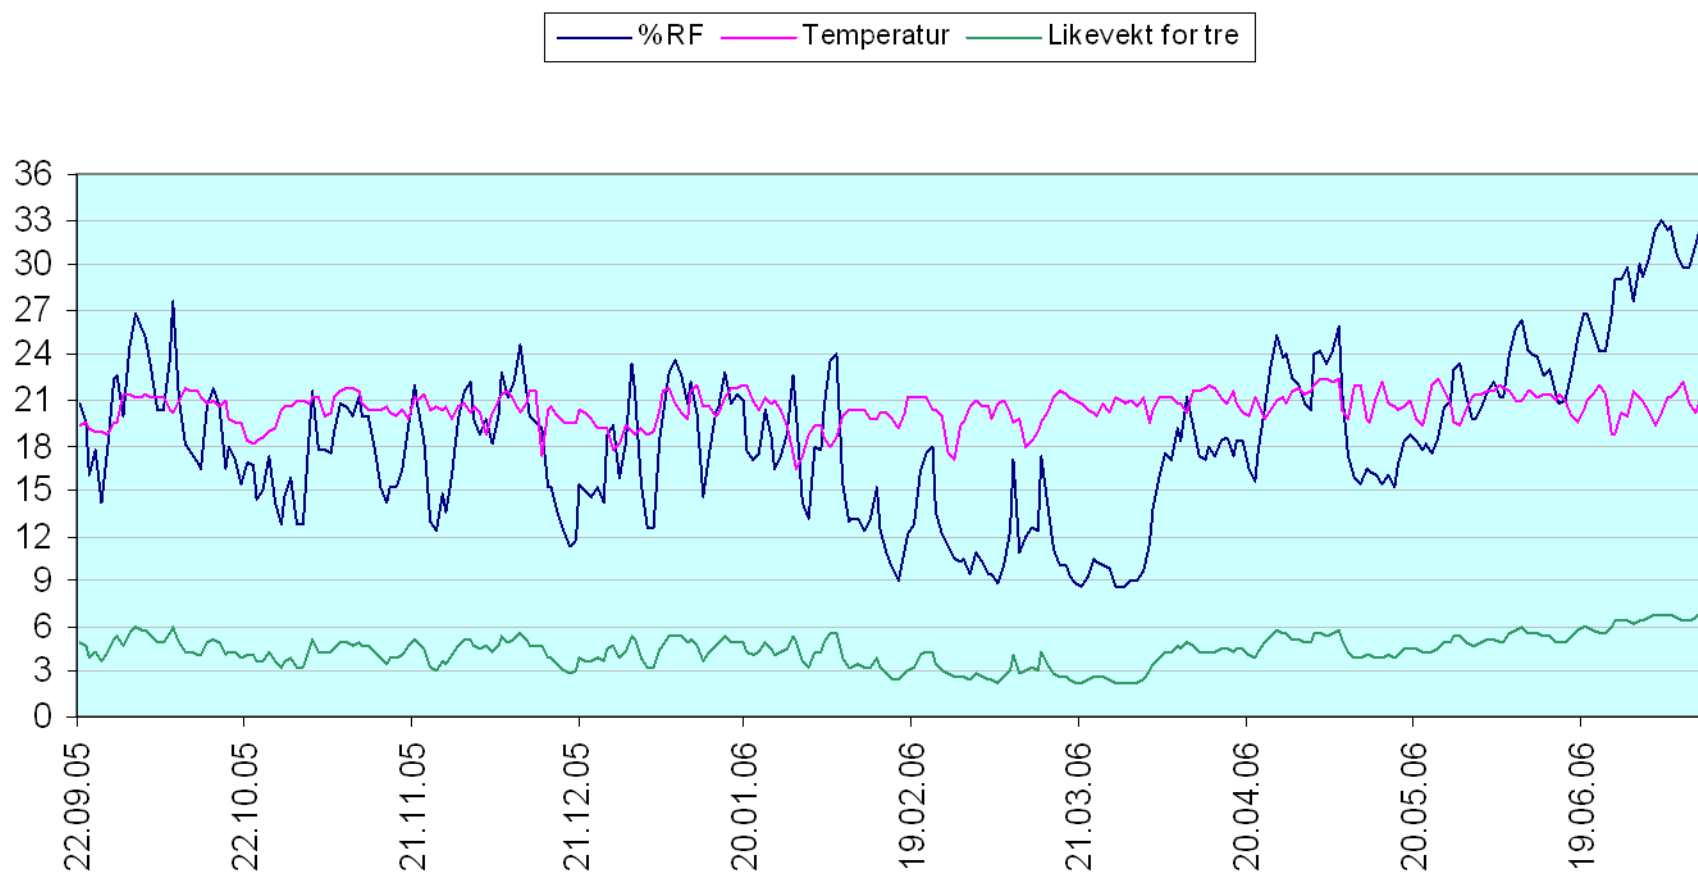
# Logged indoor values at Longyearbyen School

Daily mean from 22 September 2005 to 11 July 2006

# Indoor climate in Oslo and in Longyearbyen for the period 22 September 2005 to 4 April 2006 (cold season)

Actual outdoor values converted to indoor conditions in Longyearbyen and Oslo + logged indoor values at Longyearbyen School. The values are a mean for the period.

<b>Inneforhold</b>		
	<i>Temperatur</i>	<i>% RF</i>	<i>% LVF</i>
Estimated for Oslo	22,0	22,3	5,0
Estimated for Longyearbyen	22,0	12,7	3,1
Logged values for Longyearbyen	20,3	16,7	4,1

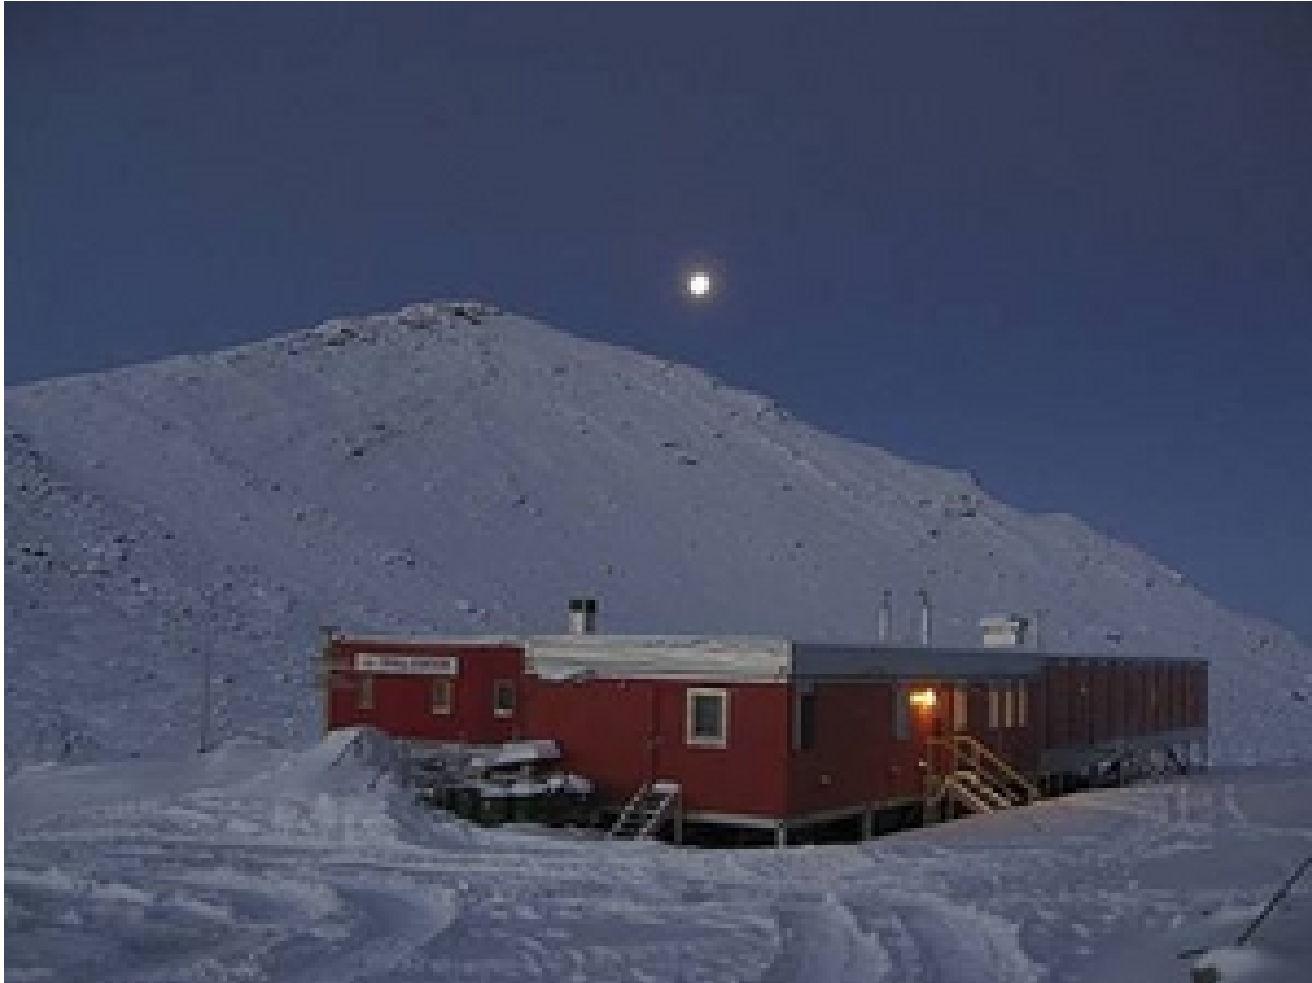
# Logger placed on the research station Troll in Antarctica

**Parquet of heat-treated birch – shall tolerate low RH over time.**
